Mansfield transform patient experience

Designed as a landmark building for Mansfield, the redevelopment of Mansfield Community Hospital was an integral part of the overall strategy of transforming the health delivery system for Mansfield District Primary Care and Sherwood Forest Hospitals NHS Trust

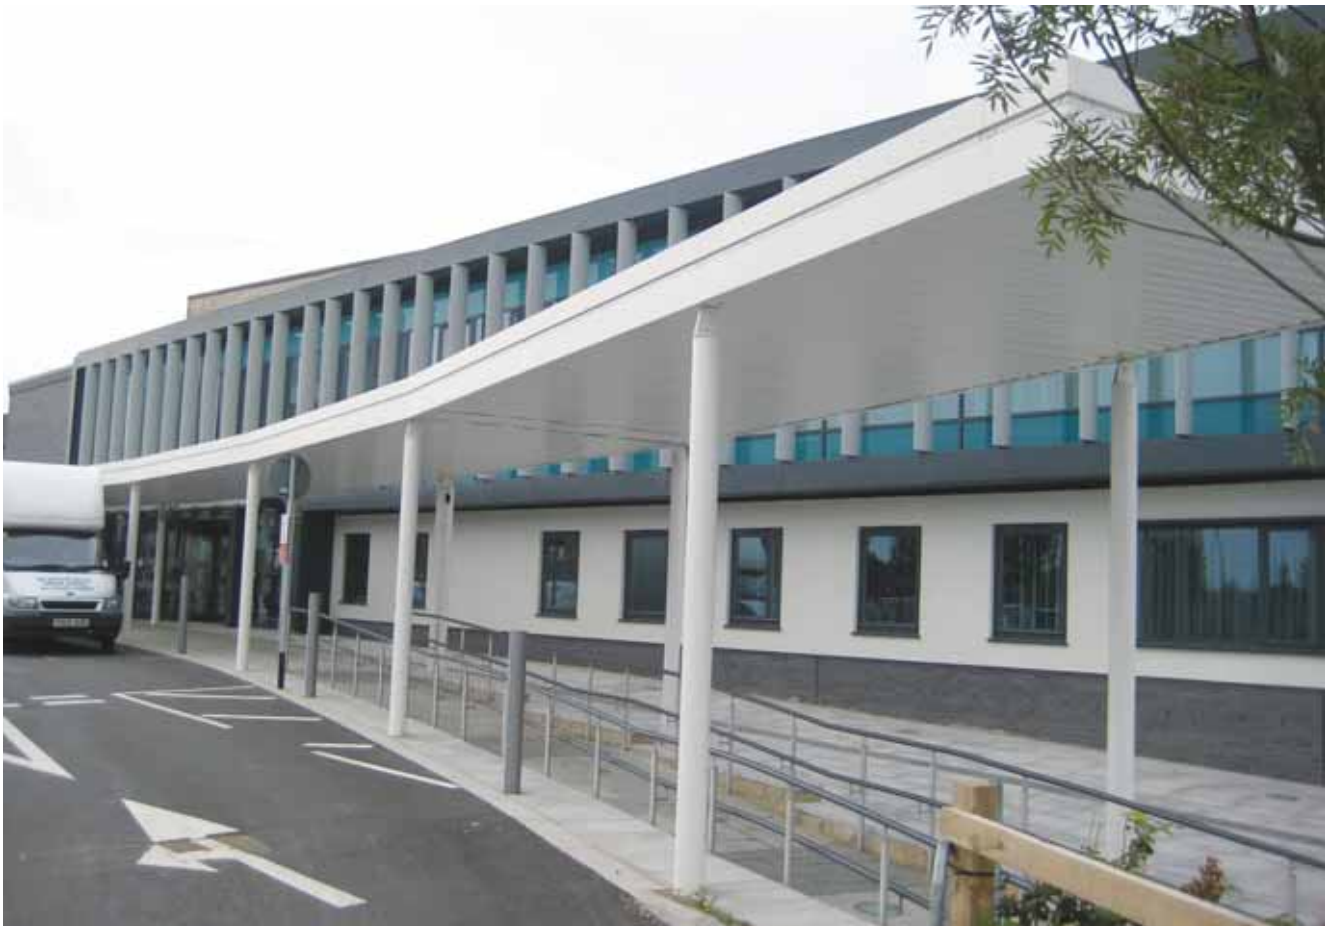
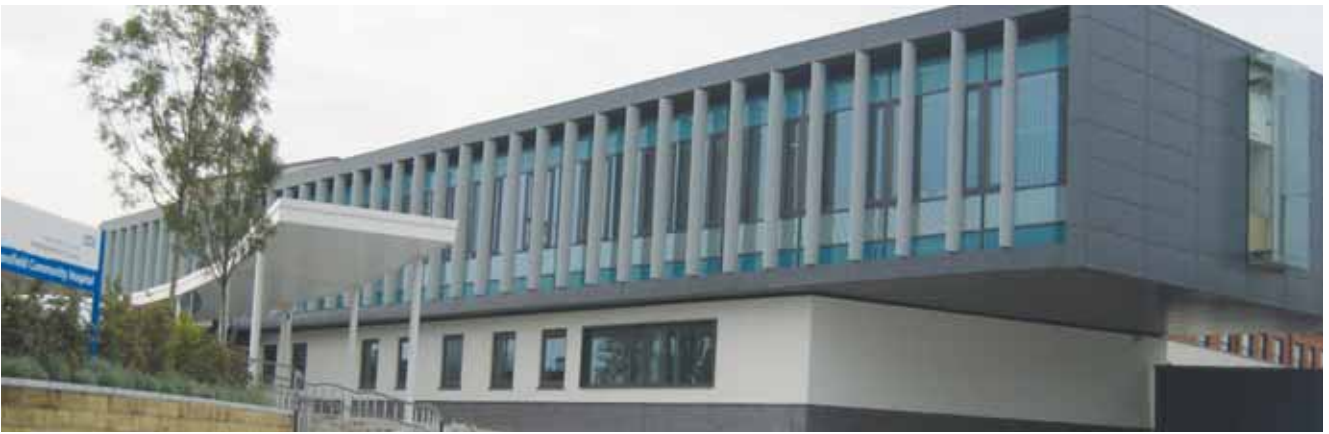
Only two storeys tall, the hospital second storey cantilevers dramatically beyond the face of the building. The first floor is clad in lighter materials (metal and glass) while the ground floor base is materialised in render and brick. On the east side, a distinctive ledge frames the cantilevered part of the building, and is filled in with large glass panels protected

by a series of metal vertical fins, giving solar protection, rhythm and colour to the façade. The glass curtain wall incorporates windows which can be opened for natural ventilation while the ledge allows access for window cleaning and maintenance. The west side is a curtain wall with coloured spandrel panels.

One of the main issues which had to be dealt with was the fire prevention on the curtain walling/compartment floor. This detail was the topic of much conversation at the design stage and on site fixing. Specialist fire prevention companies had to be involved and each detail onsite had to be carefully scrutinised.

The spandrel panels came with insulation fixed to the rear, and caused a number of problems due to the dew point position changing. Additional insulation had to be

incorporated to negate interstitial condensation and meet the Robust Detail Requirements.
